FIRST REPORT
REGARDING
POST-DISASTER REMEDIATION
OF
2023 THESSALY FLOODING

ID#: 20249B01

October 2023

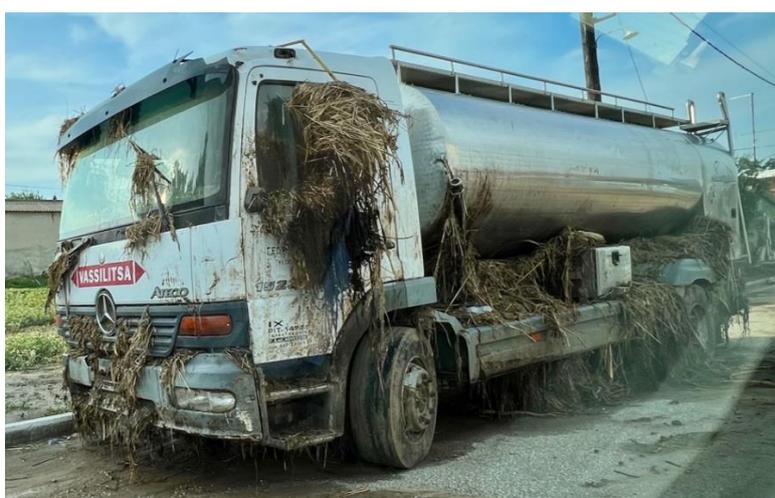
Figure 12: The flash flooding is clearly evidenced by this destroyed bulk milk transport truck in Nea Lefki which could have been driven to safety but even that was not possible.

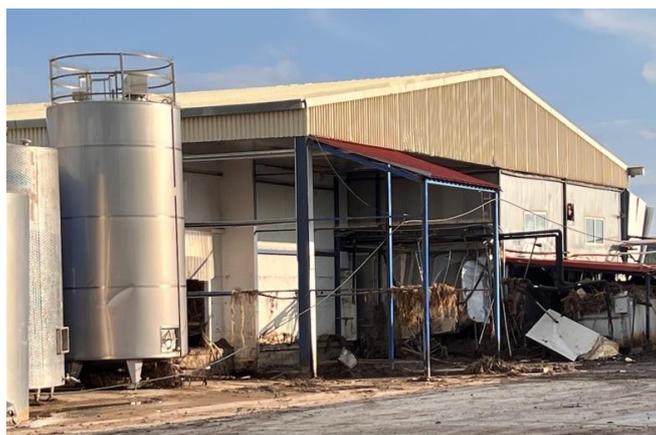
In addition to the devastation on farms, the floods also had a profound impact on the processing sector. Extensive damage to a number of processing plants has rendered many of them inoperative. The damage varied greatly, from complete destruction in a matter of hours to some hardly being damaged at all.

Figure 15: Completely destroyed Feta cheese factory.
